**Teignbridge District Council  
Economy and Assets**

## **Stokeinteignhead Flooding Appraisal: Causes and Alleviation**

**Report date: March 2014**

<b>Site Name</b>	Stokeinteignhead: Village
<b>Scope</b>	Flooding Appraisal: Causes and Alleviation.
<b>Report Reference:</b>	1622
<b>Report Status:</b>	Draft
<b>Report Date:</b>	3 <sup>rd</sup> March 2014
<b>Report Author:</b>	R. Selby B.Sc., C.Eng.,MICE.
<b>Report Approval:</b>	M. Stewart

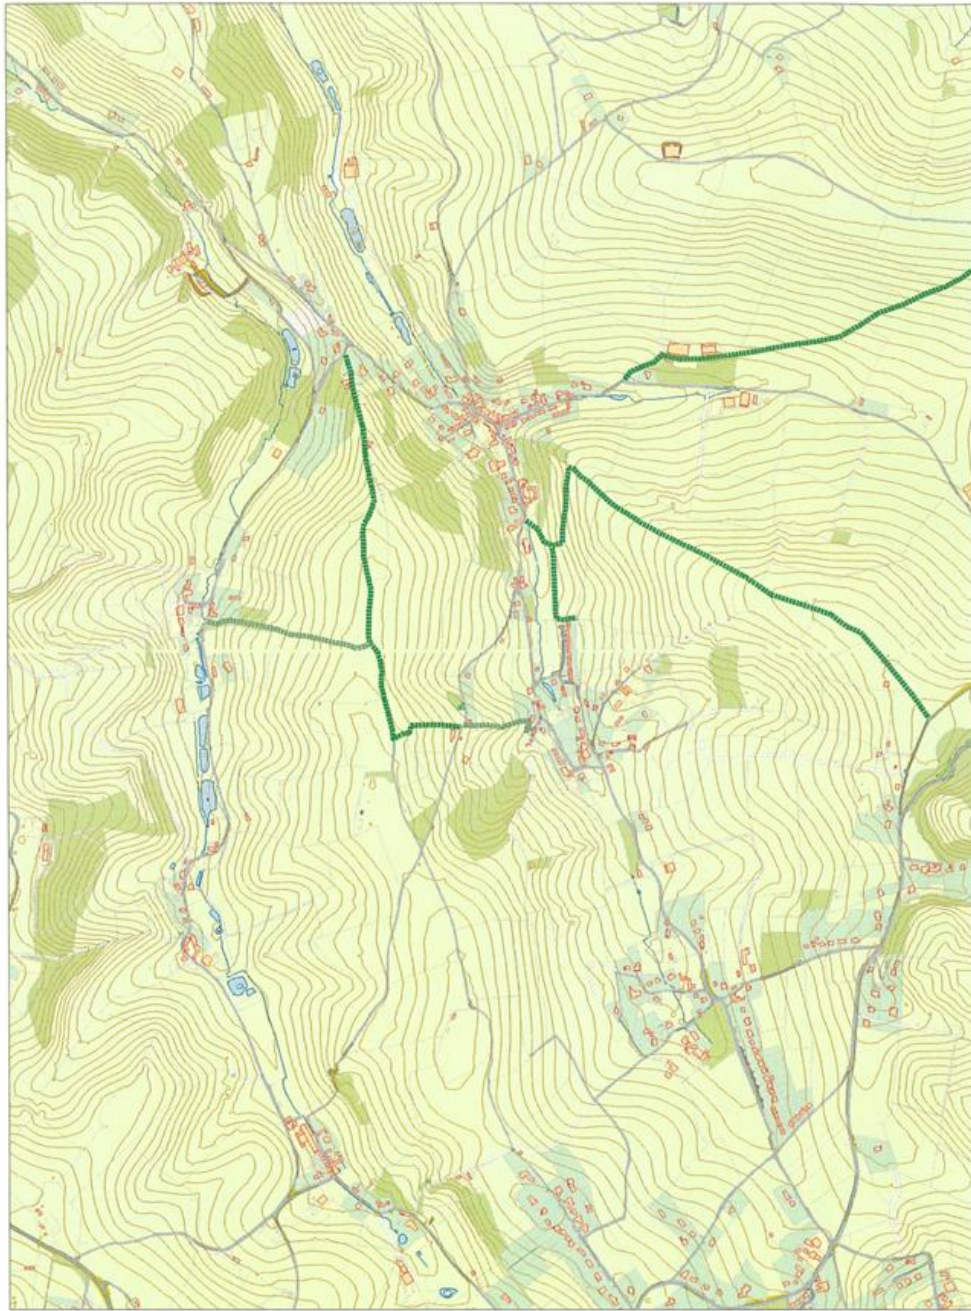
Appendix 3.1.6 Green Lanes Map (NTS)

- 2.3.4 The underlying geology where exposed is readily susceptible to weathering and erosion. Unmade “green lanes” abound around the village, many of them with steep gradients, and in them the underlying bedrock has become exposed. Their economic use for access and stock movement over the years and more recently by the leisure activities of off roaders has resulted in the acceleration of the natural weathering and erosion processes and now many of them form sunken surfaces along which pluvial flows are constrained They form a network of artificial “arroyos”, typical of hotter drier climates, with their eventual outfall in the village centre. When operating they transport quantities of loose silts, sands and gravels, onto the highway network and direct them towards the village centre. The ownership and maintenance responsibilities as well as the usage rights for Green Lanes can be difficult to establish. A useful article summarising the status, classifications and usage rights for Green Lanes can be found at the Wikipedia website ([http://en.wikipedia.org/wiki/Green\\_lane\\_\(road\)](http://en.wikipedia.org/wiki/Green_lane_(road))). <http://gis.devon.gov.uk/basedata/viewer.asp?DCCService=prosection31> is a further link to Devon County Council revealing an interactive map of Public Rights of Way (PROW) which shows which of the green lanes around the village to be PROW's. A map of some of the green lanes in the catchment is included in Appendix 3.1.6.

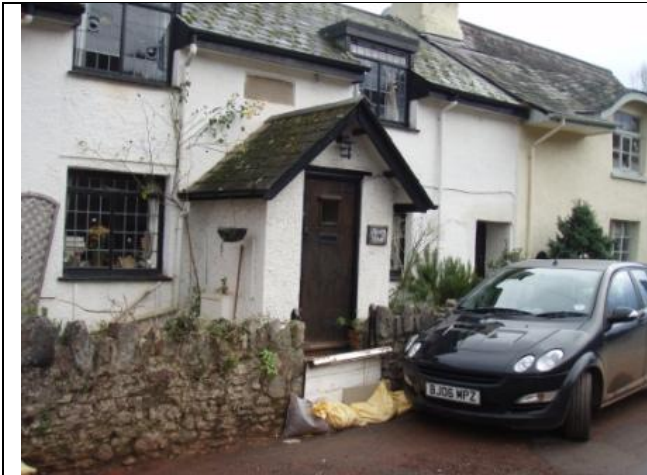
Old school, main entrance - SX9163370460 looking E

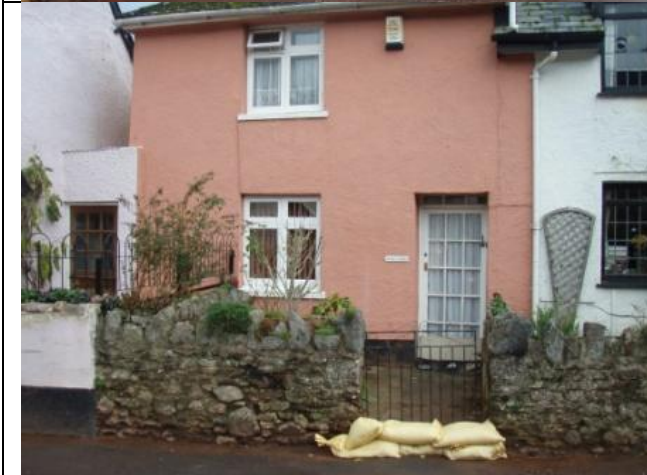
School house sandbagged and flood boards on front door – not reported to have flooded, SX9162970467 looking E

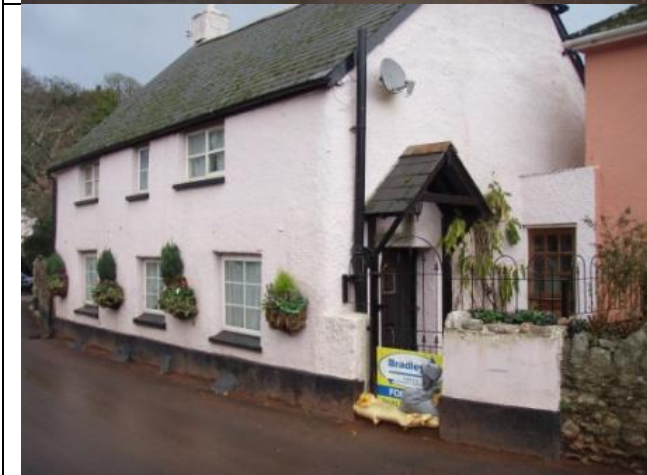
Rose Cottage, uphill door sandbagged, SX9162970467 looking NE

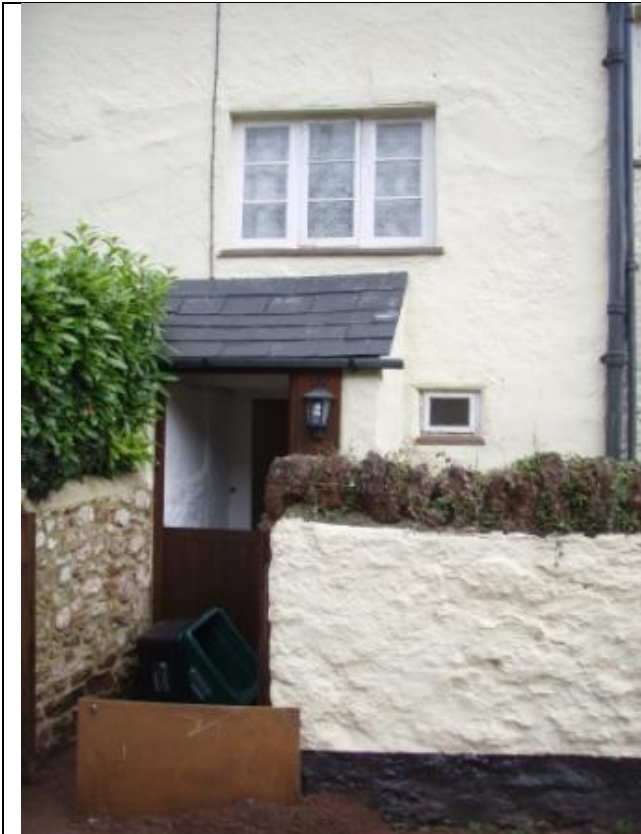
Lower door of Higher Farm which had a small amount of flood water in. SX9166070366 looking E

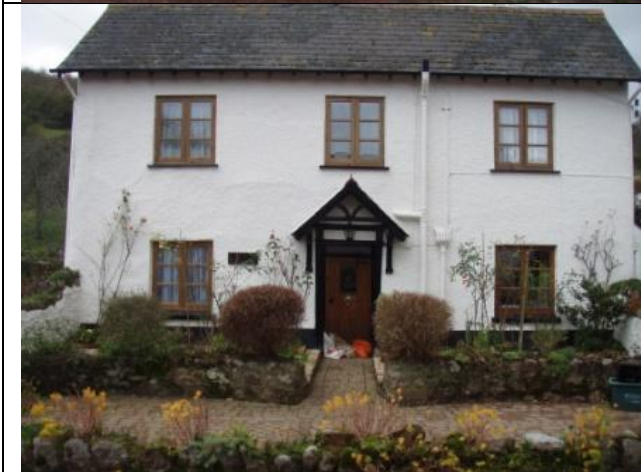
Congdons Farm, some improvised sandbags but there was seepage through the door. SX9162170473 looking W

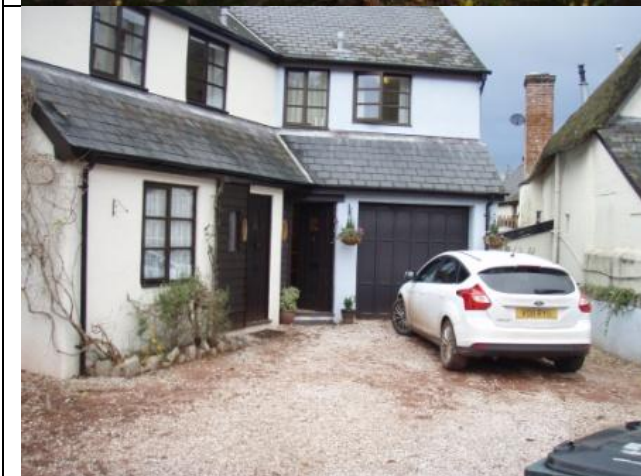
Tinkers and Rendell Cottages on school road – resident reported having to work hard to keep flood water out they are adjacent to culverted channel and worked to keep drain upstream clear of debris to prevent build up of water in road and driveway. SX9161870477 looking N

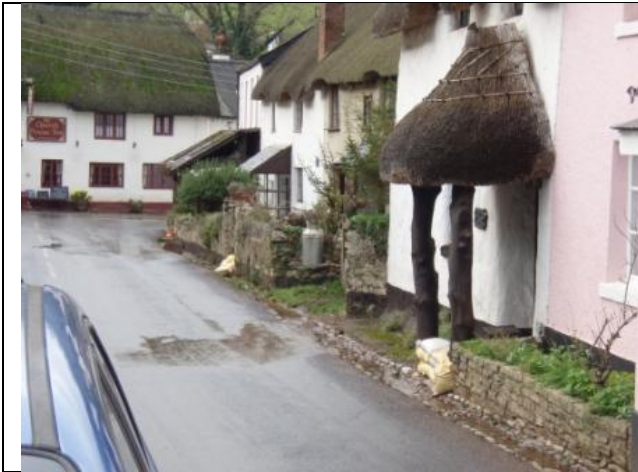
Sand bagged properties on Deane Road SX9164570516 looking W

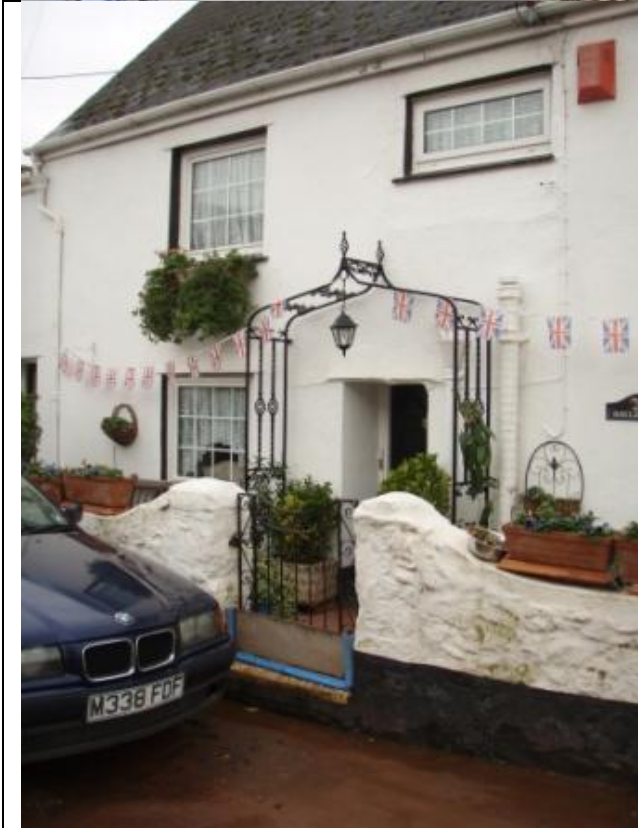
Daylesford, improvised flood board on gate – not reported flooded. SX9157170539 looking NE

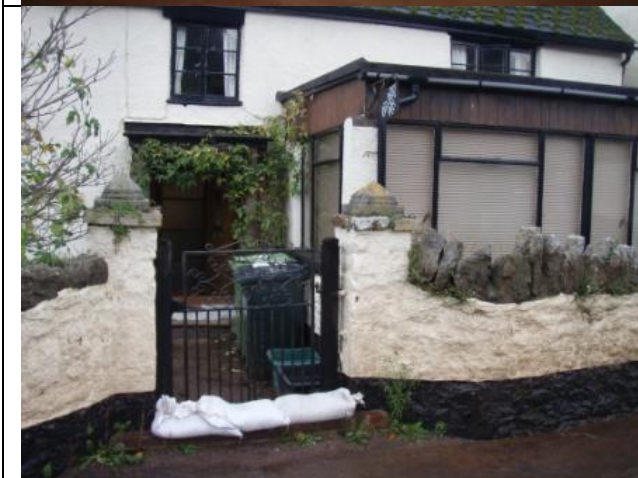
Old Bailey Farm – resident managed to keep flood water out of property through combination of raised steps and sandbags. He complained that vehicles driving through the village were creating bow waves which overtopped his defences by the gate. SX9158270528 looking NE

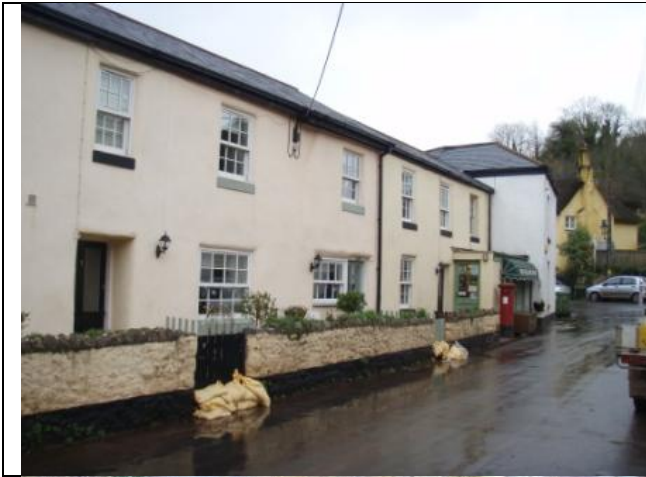
View of sandbagged properties (1&2 Orchard Cottages – gardens flooded) towards Post Office. SX9158970520 looking W

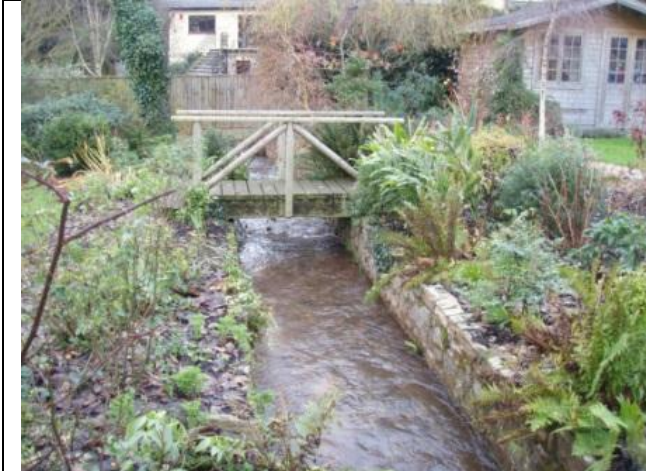
Maintained channel at back of Victoria Farm, SX9152770565 looking N

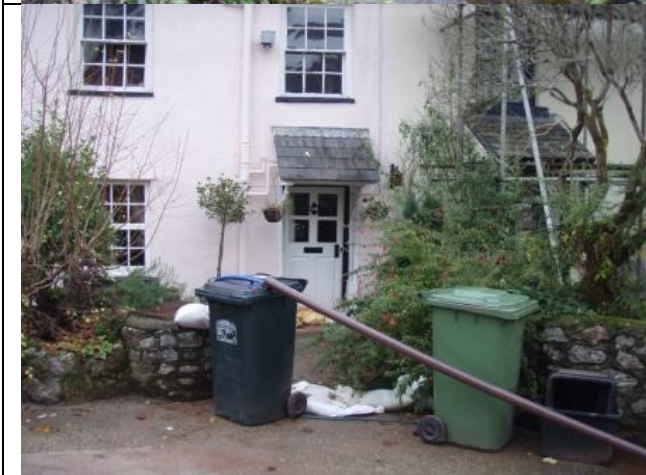
Pumping out well to lower levels at Holly Cottage SX9150870542 looking W

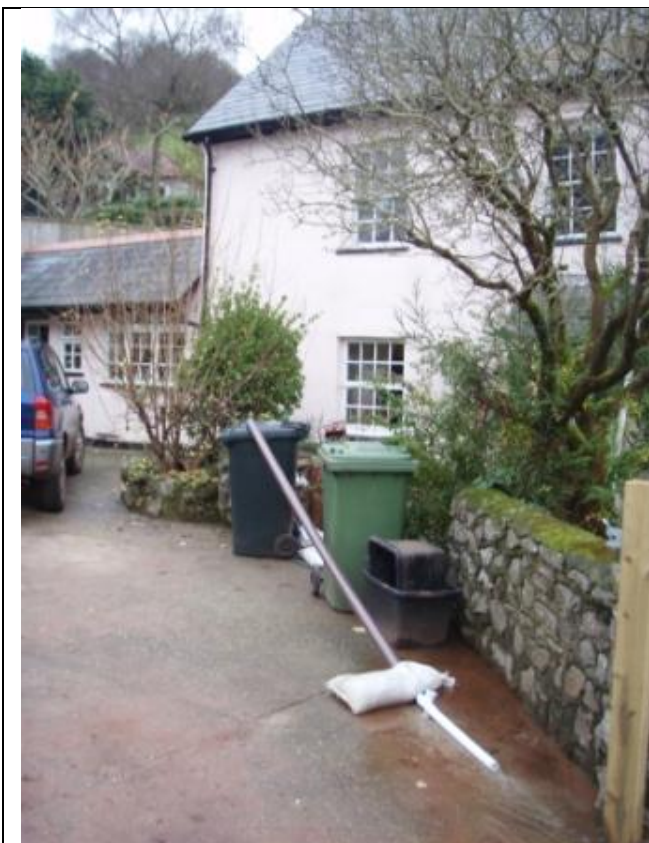
Pumping out well to lower levels at Holly Cottage SX9150870542 looking S

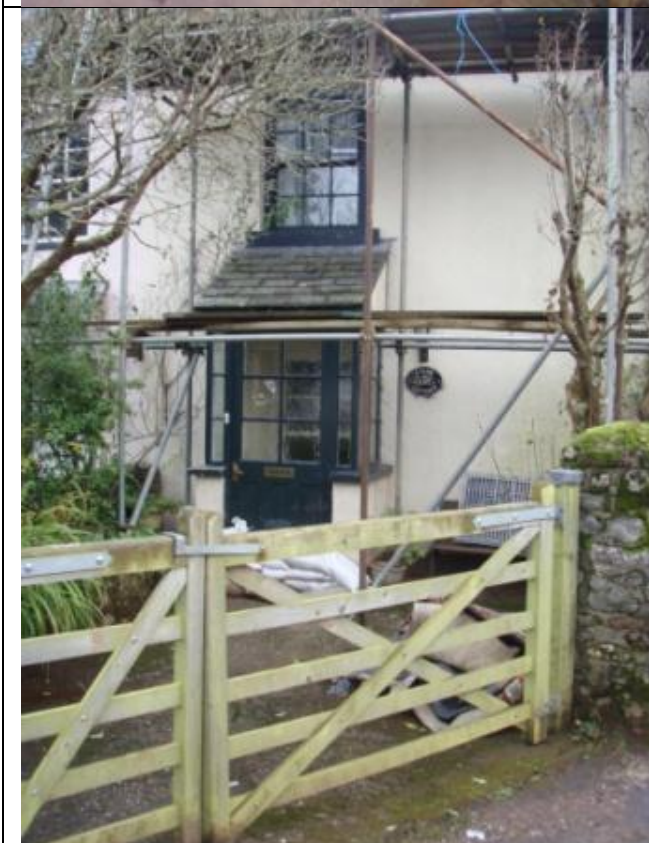
Damaged carpets outside Lilac Cottage, SX9150570551, looking SW

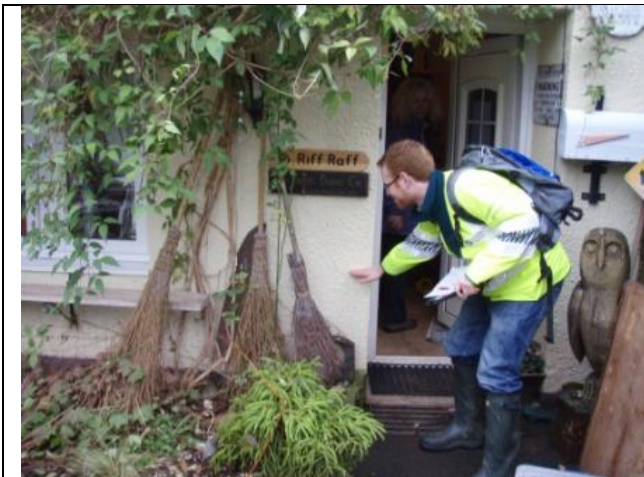
Flood level at The Lodge,  
SX9151370564 looking NW

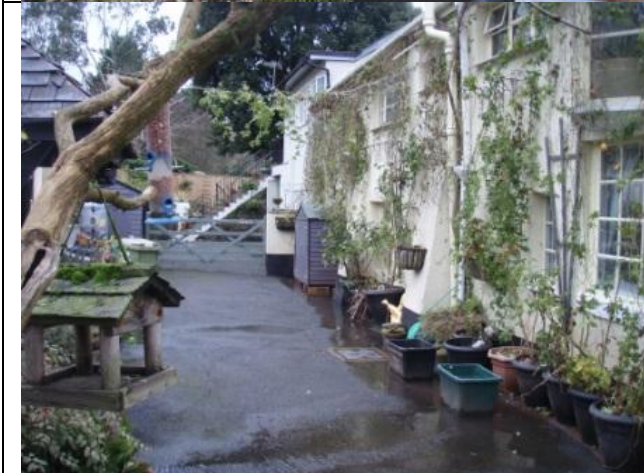
Flow followed down path down to  
garage at rear of The Mews,  
SX9150370569 looking NW

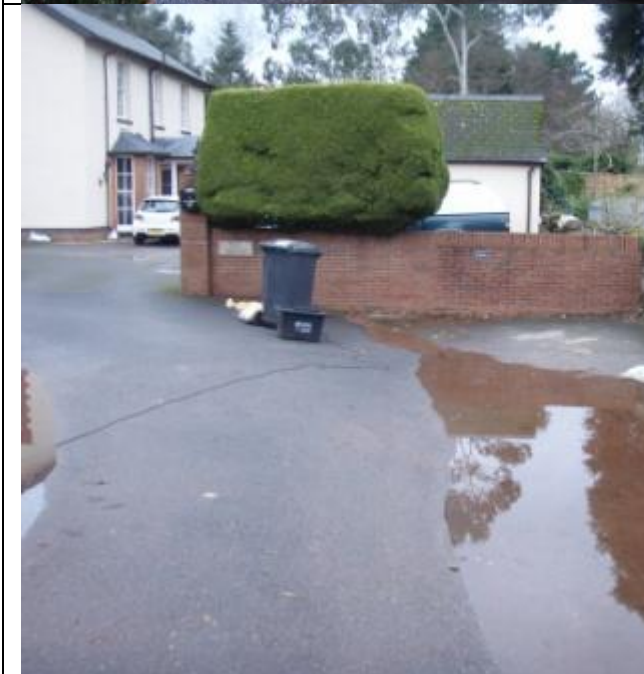
Low point showing remaining  
water on driveway to The Gables,  
SX9149870564 looking NW

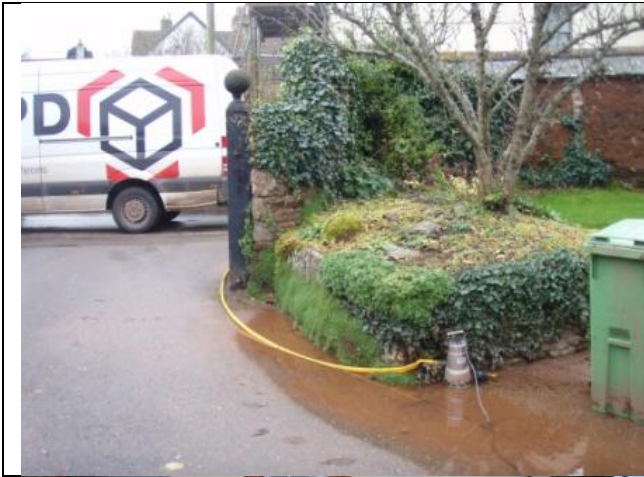
remaining water on driveway to  
The Gables, SX9149870564  
looking S

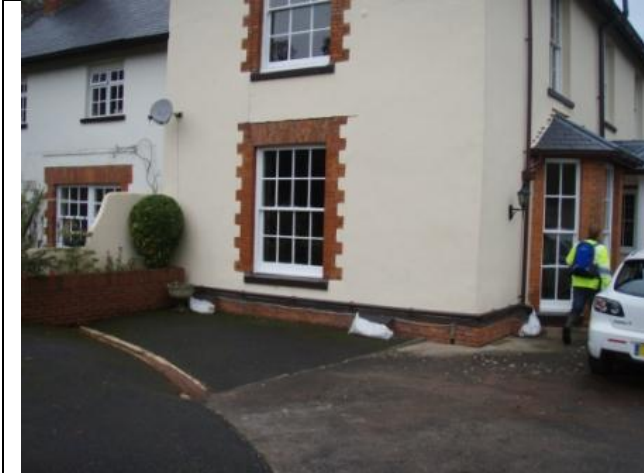
The Gables, sandbags over  
airbricks SX9148070570 looking  
NW

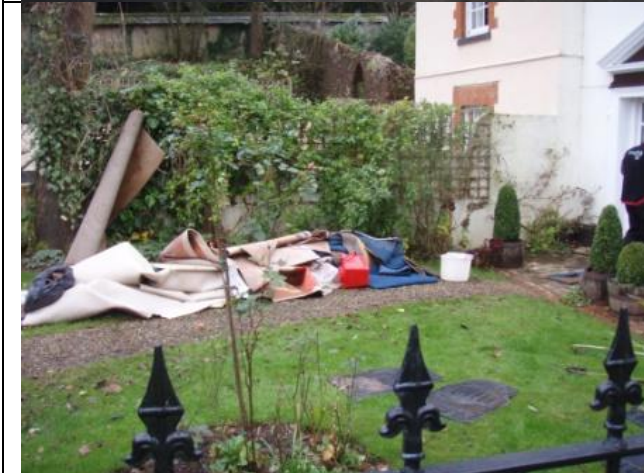
Flood damaged property at the  
Gables SX9147570568 looking W
