**Teignbridge District Council  
Economy and Assets**

## **Stokeinteignhead Flooding Appraisal: Causes and Alleviation**

**Report date: March 2014**

<b>Site Name</b>	Stokeinteignhead: Village
<b>Scope</b>	Flooding Appraisal: Causes and Alleviation.
<b>Report Reference:</b>	1622
<b>Report Status:</b>	Draft
<b>Report Date:</b>	3 <sup>rd</sup> March 2014
<b>Report Author:</b>	R. Selby B.Sc., C.Eng.,MICE.
<b>Report Approval:</b>	M. Stewart

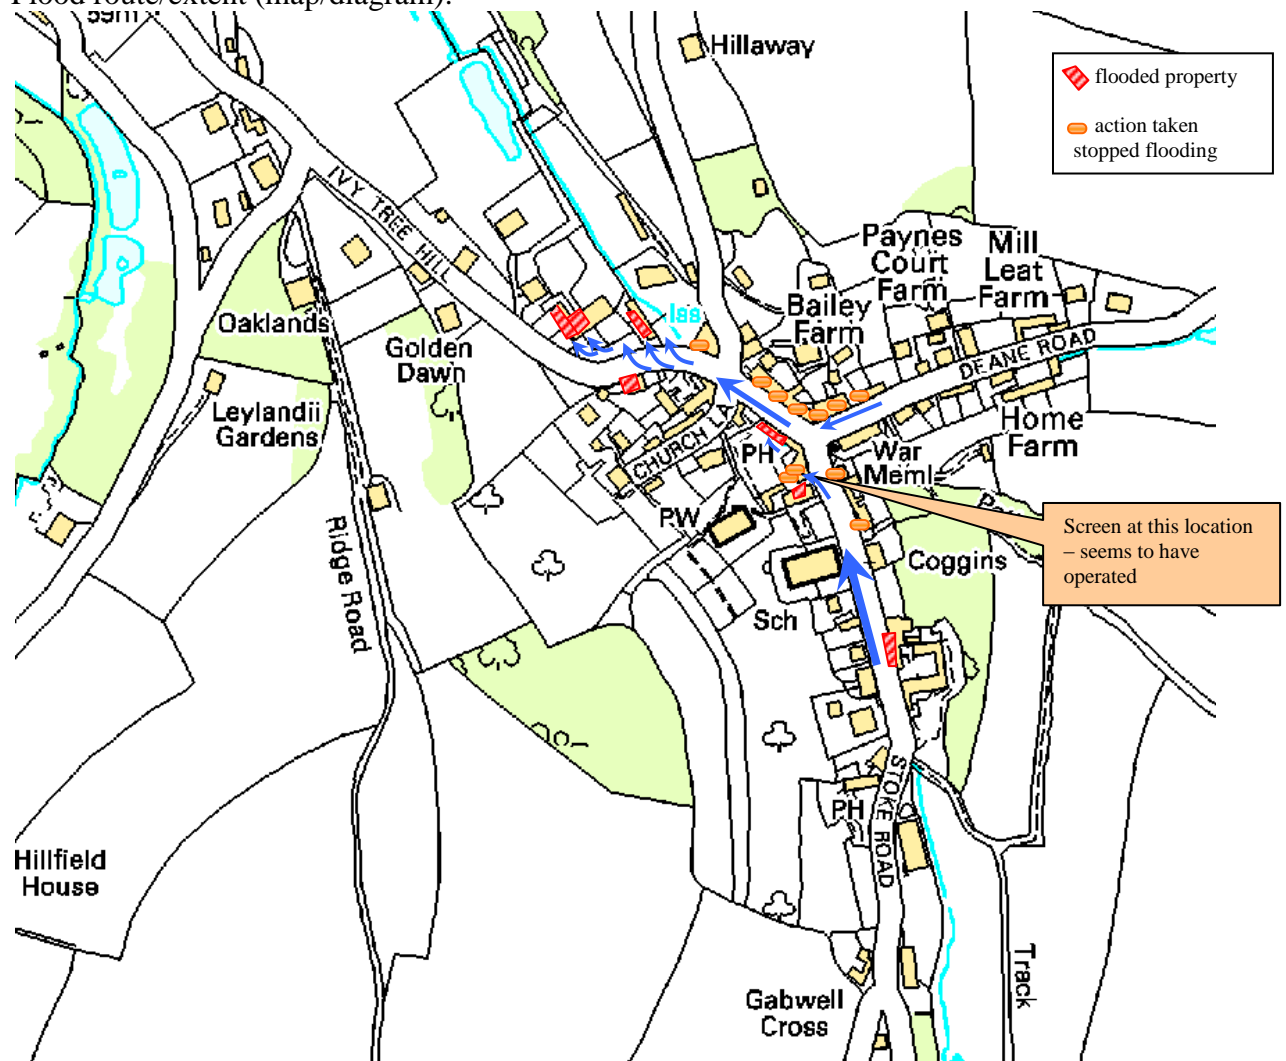
Flood route/extent (map/diagram):

Flood Sources: Fluvial, Surface Water, Groundwater

Flooding from ordinary watercourse and surface water through the village. Many properties along the main road through the village
